REPORT DOCUMENTATION PAGE		READ INSTRUCTIONS BEFORE COMPLETING FORM
1. REPORT NUMBER	2. GOVT ACCESSION NO.	3. RECIPIENT'S CATALOG NUMBER
	AD-A405771	
4. TITLE (and Subtitle) Phase I Inspection Report Cornwall Upper Reservoir Dam Lower Hudson River Basin, Orange County, NY Inventory No. 604		5. TYPE OF REPORT & PERIOD COVERED Phase I Inspection Report National Dam Safety Program

PHASE I INSPECTION REPORT
NATIONAL DAM SAFETY PROGRAM
CORNWALL UPPER RESERVOIR DAM
I.D. No. NY 604
DEC DAM No. 195B-1148 LOWER HUDSON RIVER BASIN
ORANGE COUNTY, NEW YORK

Name of Dam: Cornwall Upper Reservoir Dam
(I.D. No. NY 604)

Dates of Inspection: 8 January 1981
11 March 1981

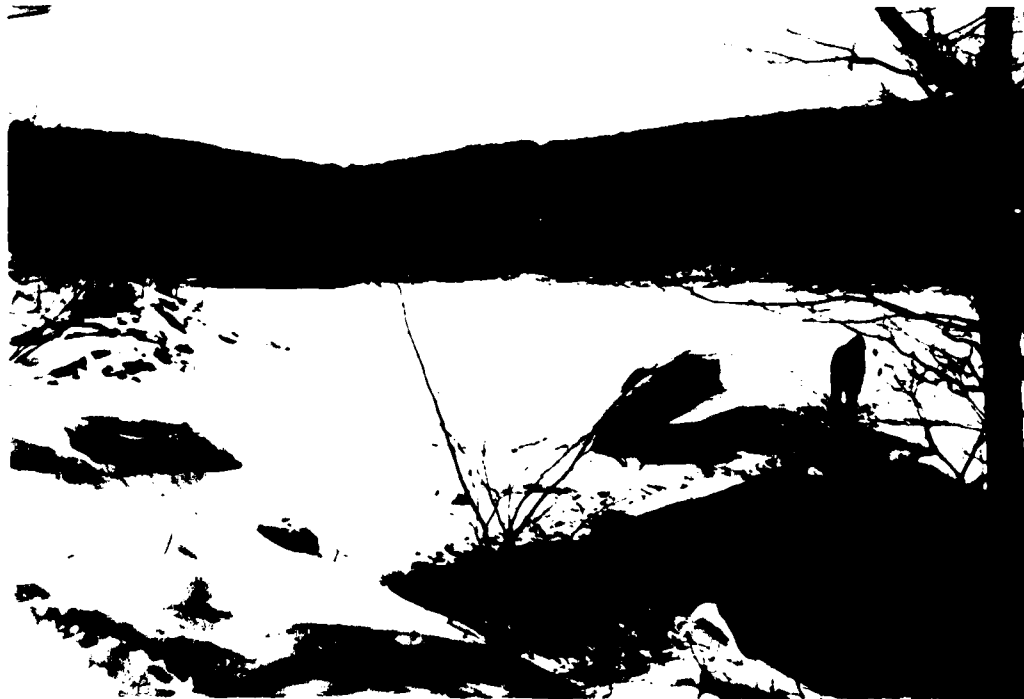
Two local depressions approximately 0.7 foot deep along the crest of the dam, one in the center of the dam, the other 150 feet from the left abutment. The left spillway training wall and the adjacent crest elevation are 0.9 feet below the average crest of the dam. On the downstream slope, there are four or five tree trunks with diameters 4 to 8 inches. Superintendent Ralph Smith reported seepage near a large tree (24-inch diameter) on the downstream face near the left abutment of the dam. No seepage was observed because of the low level of the reservoir and the cold temperature.

Photo 2. Spillway from Right Abutment (Looking Upstream)
8 January 1981

1. Repair the collapsed masonry portion of the left spillway wall, and raise the wall and adjacent crest elevation to the average crest elevation. Seed the crest area.
